Documenting Russian Military Activity in the Vicinity of Ancient Ukrainian Burial Mounds:

Fortification, Destruction, and Possible Looting

A Conflict Observatory Report

September 4, 2024

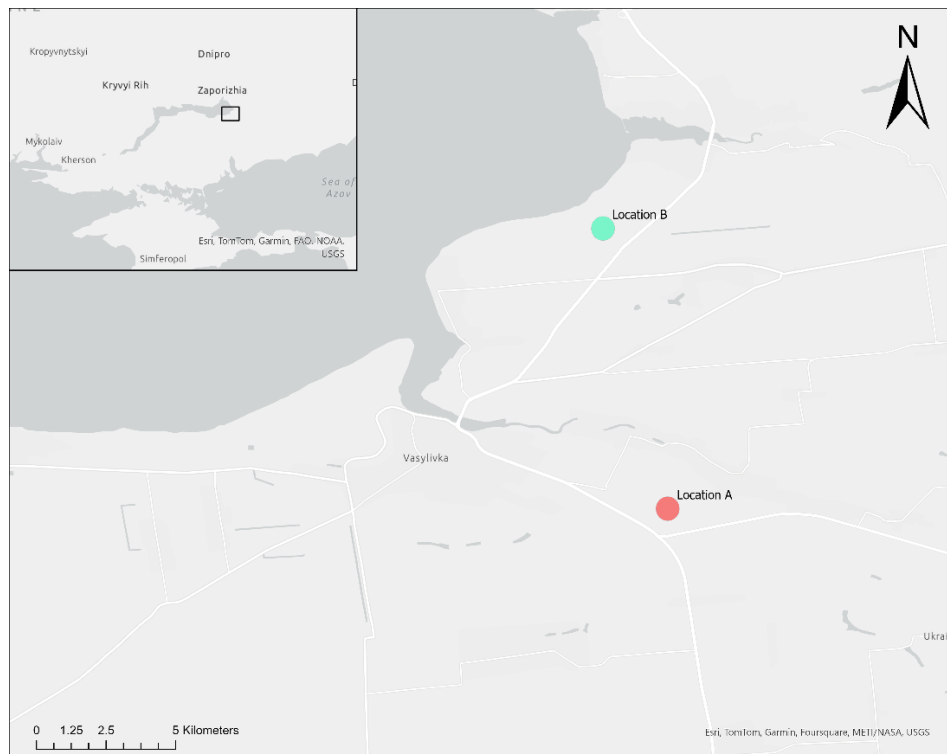
Figure 1: Map of Locations A and B in Vasylivka Raion, Zaporizhzhia Oblast (CURIA Lab)

The first site, which we identify as Location A, is approximately 6km from Vasylivka along the Karachekrak River (Figure 1). Location A is within an agricultural area. This

The second site, which we identify as Location B, is located approximately 2.5 kilometers southwest of Kamianske (Figure 1). The impacted mounds are part of the Mohyla Hrechana barrow group (No. 1773), which is a large complex of 17 barrows cataloged by archaeologists from the Zaporizhzhia Regional Museum of Local Lore in 1985.²⁹ One mound is located beside a dirt road at the eastern edge of an agricultural field some 700m west of the M18 motorway, which runs northeast to southwest connecting Kamianske and Vasylivka. A group of three further mounds (within 400m of each other, 6,200m²) are visible approximately 400m northwest of the southern mound in the uncultivated land near the banks of the Kakhovka Reservoir. The dates of the kurgans' construction and associated cultural period are unknown.

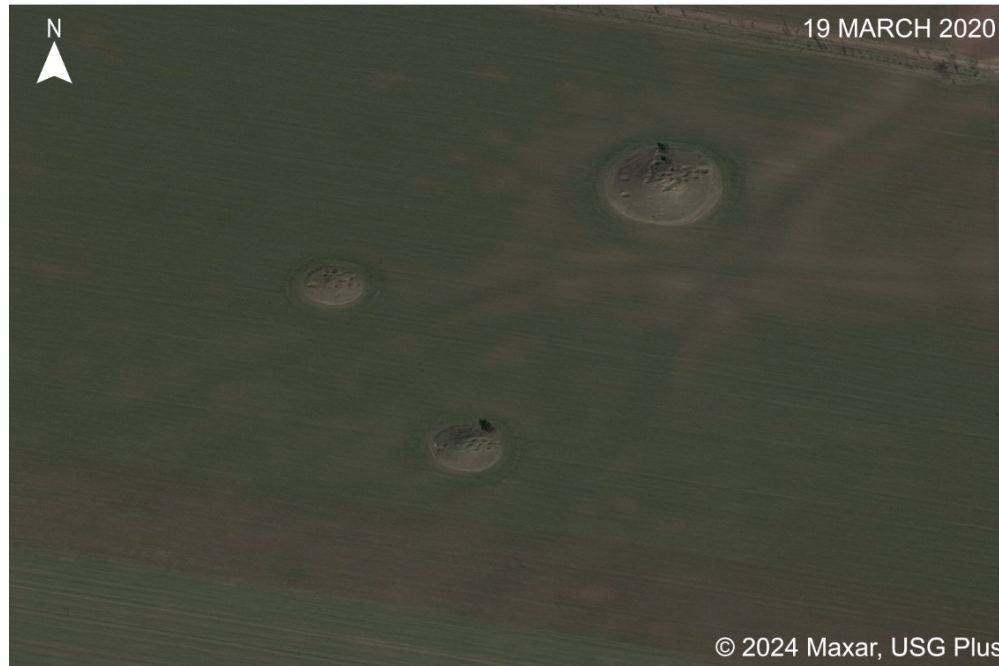
Figure 2: Satellite imagery of Location A, two years prior to occupation by the Russian Federation Armed Forces (19 MARCH 2020)

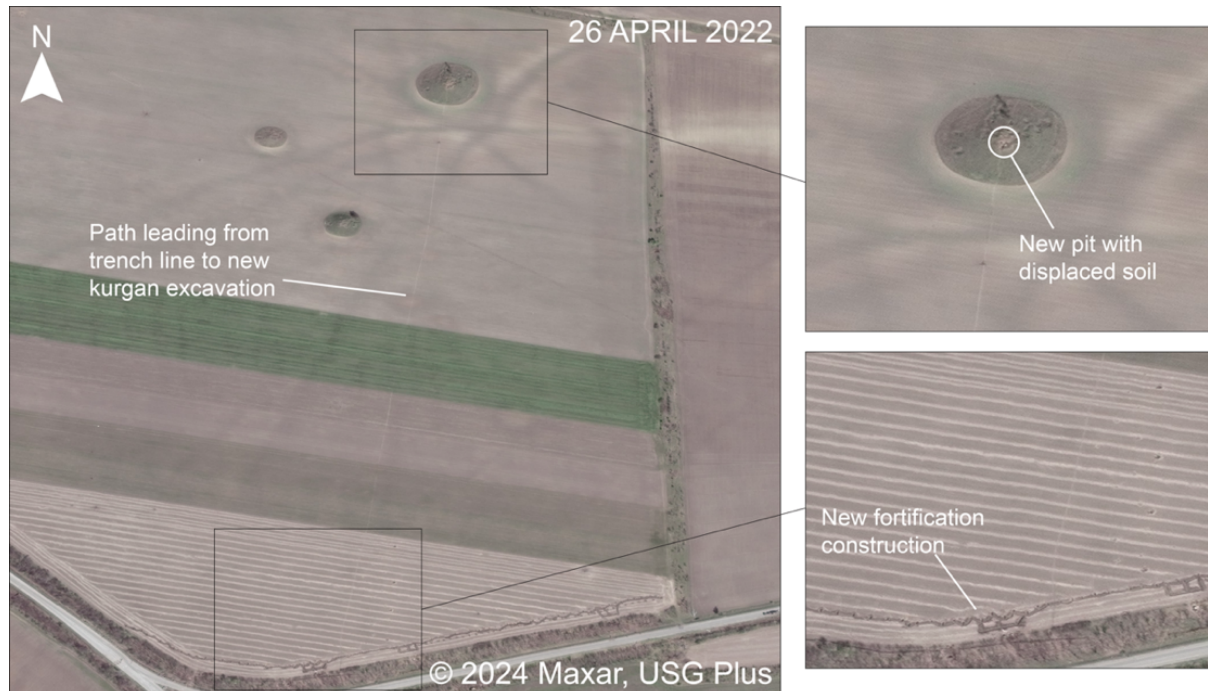
Satellite imagery from March 31, 2022, indicates that the construction of military trenches began approximately 950m south of the largest mound. Janes’ analysis identifies this location as a possible position for “troops in reserve.”²⁴ An apparent path connects the trenches in the reserve location to the top of the largest mound. By April 26, satellite imagery shows that this apparent path leads directly to what appears to be

at least one new pit in the center of the mound. Significantly, the new pit is surrounded by piles of displaced soil, a feature consistent with digging activity (Figure 3). Based on the central position of the pit, it is likely that archaeological contexts were damaged and artifactual material may have been removed.

Figure 3: New pathway leading directly from trenches under construction to new excavation activity in the center of the main mound at Location A (26 APRIL 2022)

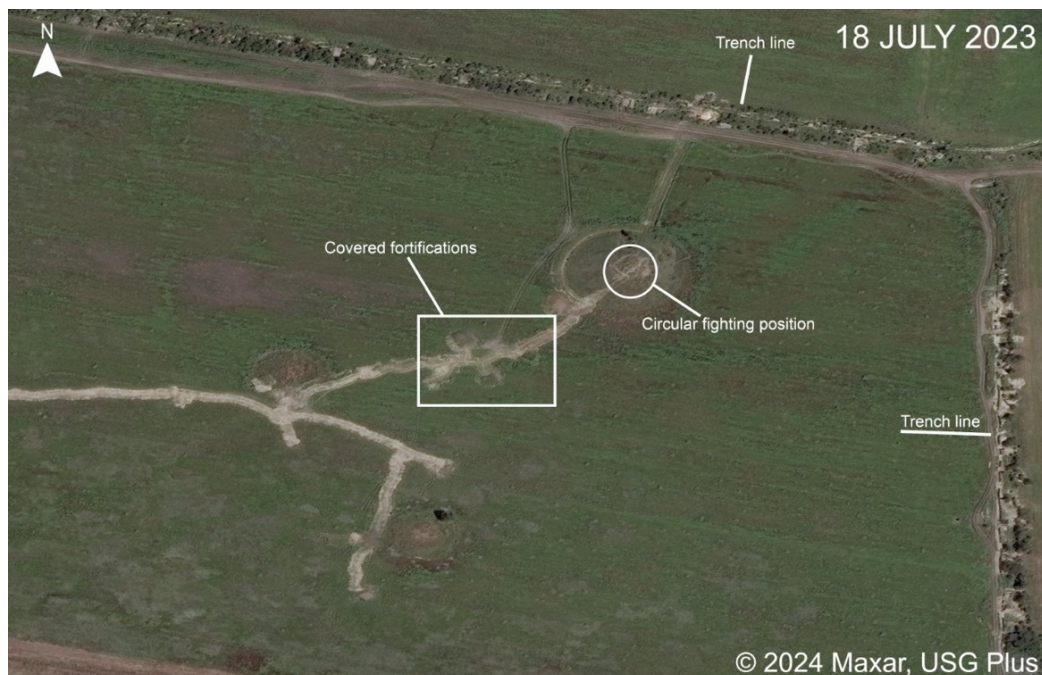
By May 15, a circular trench in the form of a fighting position for military personnel is visible on top of the largest mound, while a second line of trenches had been constructed along the path to the western barrow. Imagery from June 28 shows a substantial new network of earthworks connecting the kurgans to the western edge of the field, which includes new damage to the surfaces of the main and western mounds. The construction of additional fortifications is visible along the paths between the mounds by July 18 (Figure 4), which may have exposed archaeological contexts to damage or removal. Furthermore, using the burial mounds as military positions risks exposing them to additional conflict-related damage, such as kinetic impacts or fire.

Figure 4: Constructed network between kurgans containing covered fortifications in the center (18 JULY 2023)

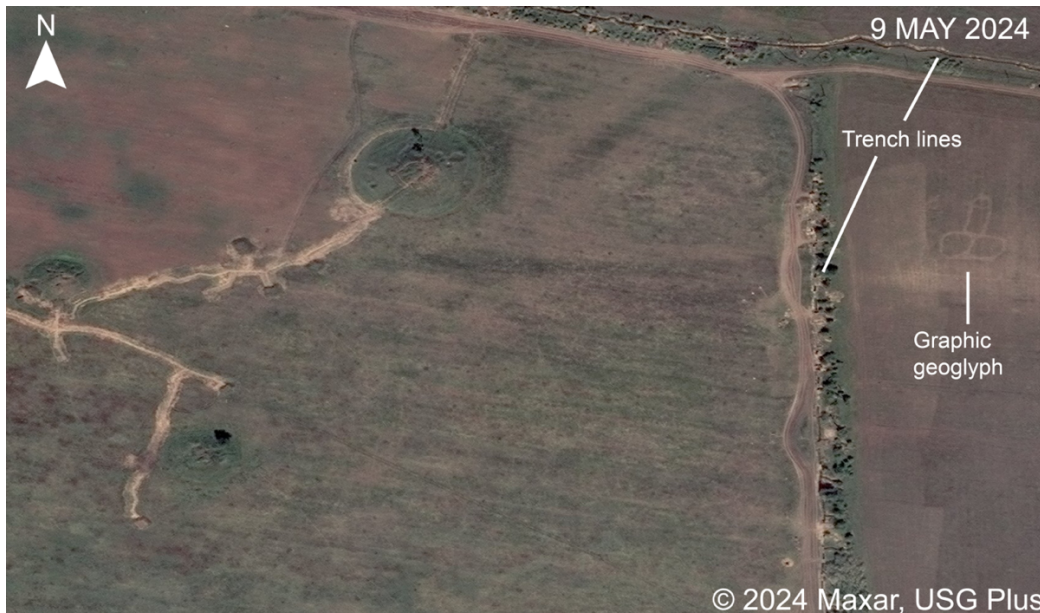
Impacts to the wider landscape are also visible in satellite imagery. In imagery from September 2023, vegetation appears to have been mowed along the north-south axis of trenches in the treeline. The mowing of vegetation in front of an entrenched position to aid visibility was noted in a separate study at other locations occupied by the RFAF and is part of Soviet and modern military engineering instructions.²⁵ On October 15, 2023, a large, graphic geoglyph is visible approximately 270m directly east of the largest mound and 70m from the trench line intersecting the area between the mound and geoglyph (Figure 5). The geoglyph is approximately 58m long and 39m wide at its maximum extent. It appears to have been mowed into the vegetation. The geoglyph remains visible in satellite imagery through July 2024. In imagery dating to June 7, 2024, six new military installations are visible between the geoglyph and the treeline east of the kurgans (Figure 6), indicating continued activity at the site.

Figure 5: Large, graphic geoglyph visible within sight of Location A trench lines (9 MAY 2024)

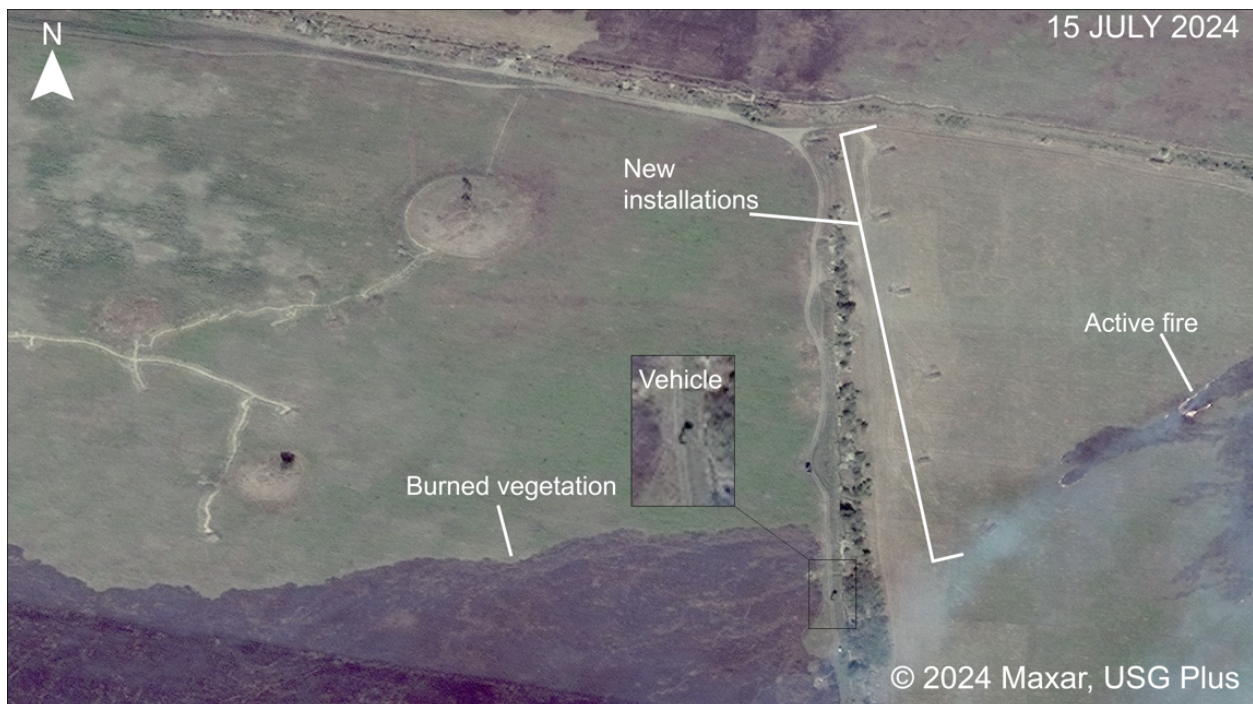
Beginning in summer 2024, the new impact of fire damage is visible. In imagery from July 15, 2024, evidence points to recent burning as well as active fires in the fields surrounding the military installations and the kurgans (Figure 6). The burned areas reach as close as approximately 80m to the southern kurgan and 110m to the main mound. At least two vehicles are visible approximately 300m east of the southern kurgan, on the dirt road running parallel to the treeline. In the period between available, electro-optical, cloudless images of Location A (June 13, 2024, to July 15, 2024), active fire data from NASA FIRMS indicates that fires occurred in the vicinity of Location A on

June 29 and July 15, 2024.²⁶ Fires risk damaging archaeological material present at or just below the surface of an archaeological site and may cause deeper impacts into the soil where vegetation roots are present.²⁷ Fire not only damages the plant species that are burned on the surface of the mound; the subsequent lack of an organic plant layer exposes burned areas of the mound to soil erosion, which could further damage the mounds and the associated archaeological material.

Figure 6: New military installations and evidence of active fires and burned vegetation (15 JULY 2024)

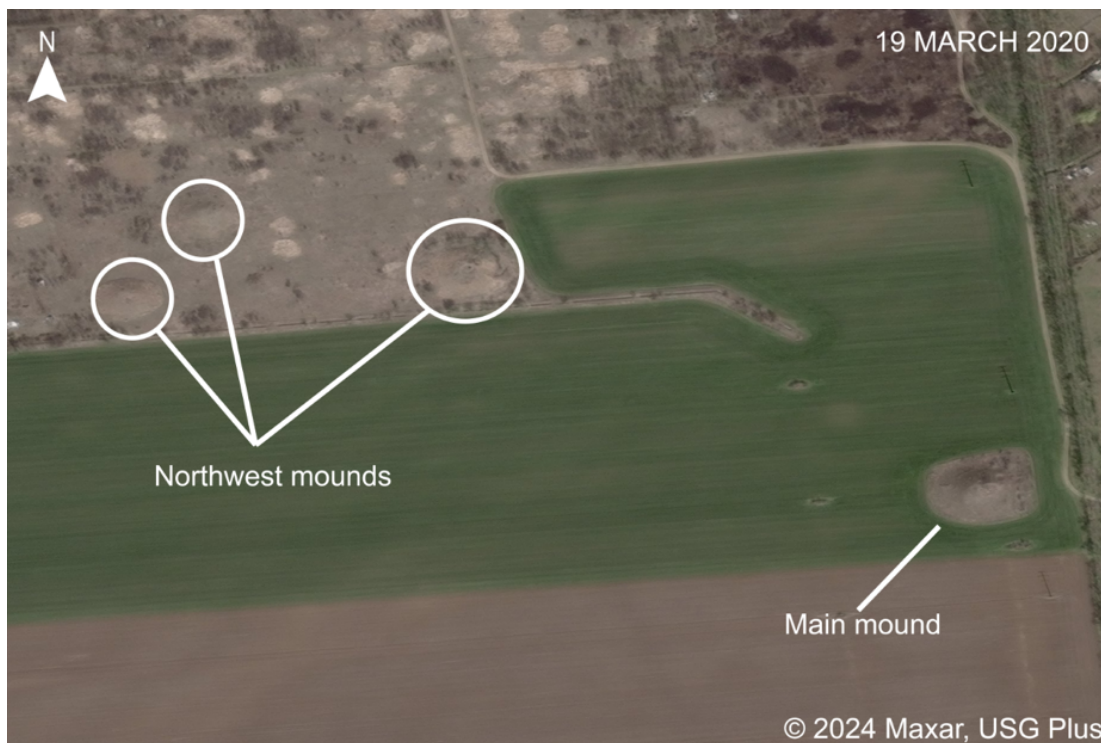
Figure 7: Satellite imagery of Location B, two years prior to occupation by the Russian Federation Armed Forces (19 MARCH 2020)

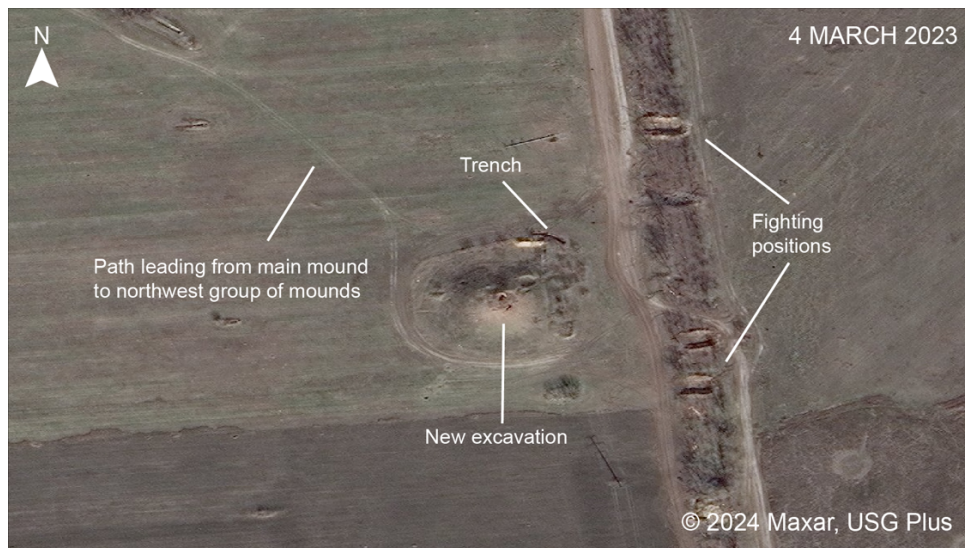
fortifications are present approximately 240m south of the southern mound. By February 24, 2023, the construction of a larger series of fortifications is visible within 200m of the southern mound, and new, irregular pits and displacement of soil consistent with digging are identifiable on top of the main mound. On March 4, new fortifications are present directly east, and within 50m, of the main mound. An additional fortification appears to have been installed directly on the northeast side of the main mound (Figure 8). Further excavation on top of the main mound is visible in imagery dating to April 16. By June 3, a new dugout is visible on the eastern side of the main mound. Janes' analysis describes this feature as "suitable for the emplacement of a firing position or an armoured vehicle."³⁰

Figure 8: Excavation on top of the main mound at Location B, with additional trenching present on the northeastern edge (4 MARCH 2023)

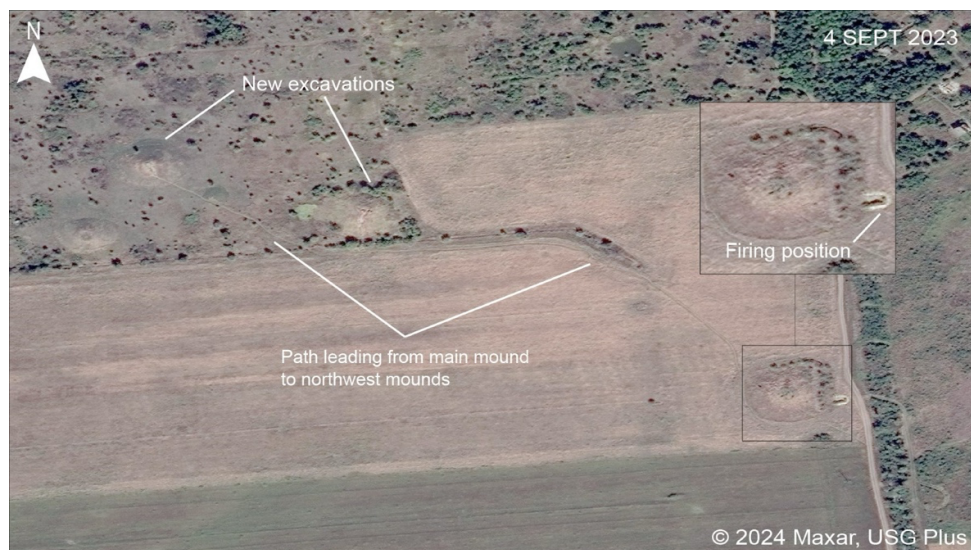
Imagery dating to July 8, 2023, shows a path leading directly from the main mound to a new excavation of a mound in the northwest group. Excavation of a third mound is visible on August 4, and by August 21 there is a southwest-northeast trench running through the center of the mound (Figure 9). At a minimum, this excavation activity has impacted the top layers of the mound. Based on the position of the excavations at the center, it is possible that significant archaeological contexts, such as burials, may have been damaged by these excavations. Moreover, professional archaeological practice is to backfill the trenches, or fill them with topsoil, when excavation has concluded, since leaving the trenches open, as appears to be the case here, exposes the interior of the mound and any associated archaeological material to weathering and erosion.

Figure 9: Damage to the kurgans in the northwest of Location B in the form of linear trenches, as well as a new firing position on the main mound (4 SEP 2023)

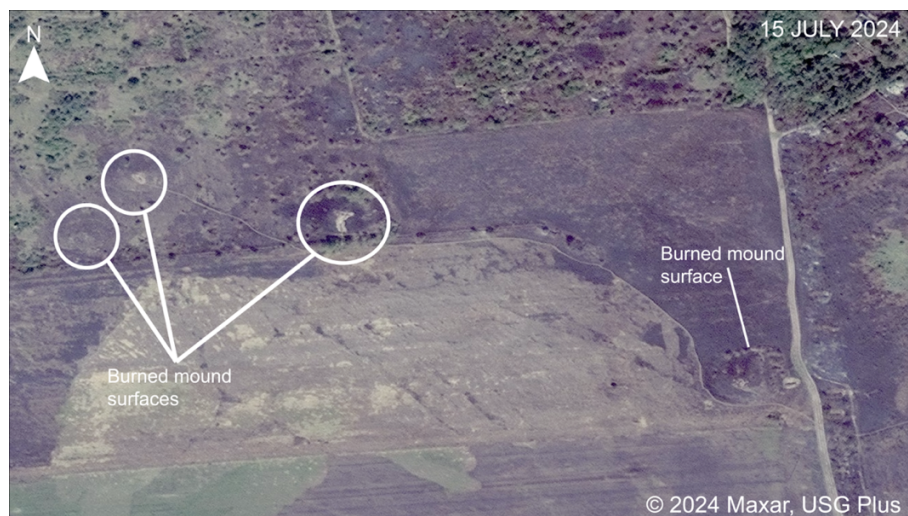
Fire impacts during summer 2024 have affected Location B as well. Between June 26 and July 6, synthetic aperture radar imagery indicates a change in vegetation occurred across a large area (approximately 0.3 km²) encompassing Location B. Active fire data from NASA FIRMS indicates that fires occurred in the area on July 2 and July 3. Another fire was recorded in the vicinity on July 11. By July 15, electro-optical satellite imagery indicates that the main mound and the northwest group of mounds were burned across most of their surfaces in the context of larger burning in the surrounding area (Figure 10). As discussed for Location A, fires risk damaging the archaeological material and further exposes the mounds to additional erosion due to the burning of the protective vegetation layer.

Figure 10: Evidence of burned vegetation across the surfaces of the mounds in Location B (15 JULY 2024)
