# Destruction of the Oskil Dam in Ukraine, March–September 2022

A remote assessment of environmental impacts

*A Conflict Observatory Report*

Compiled by: CURIA Lab  
December 26, 2024

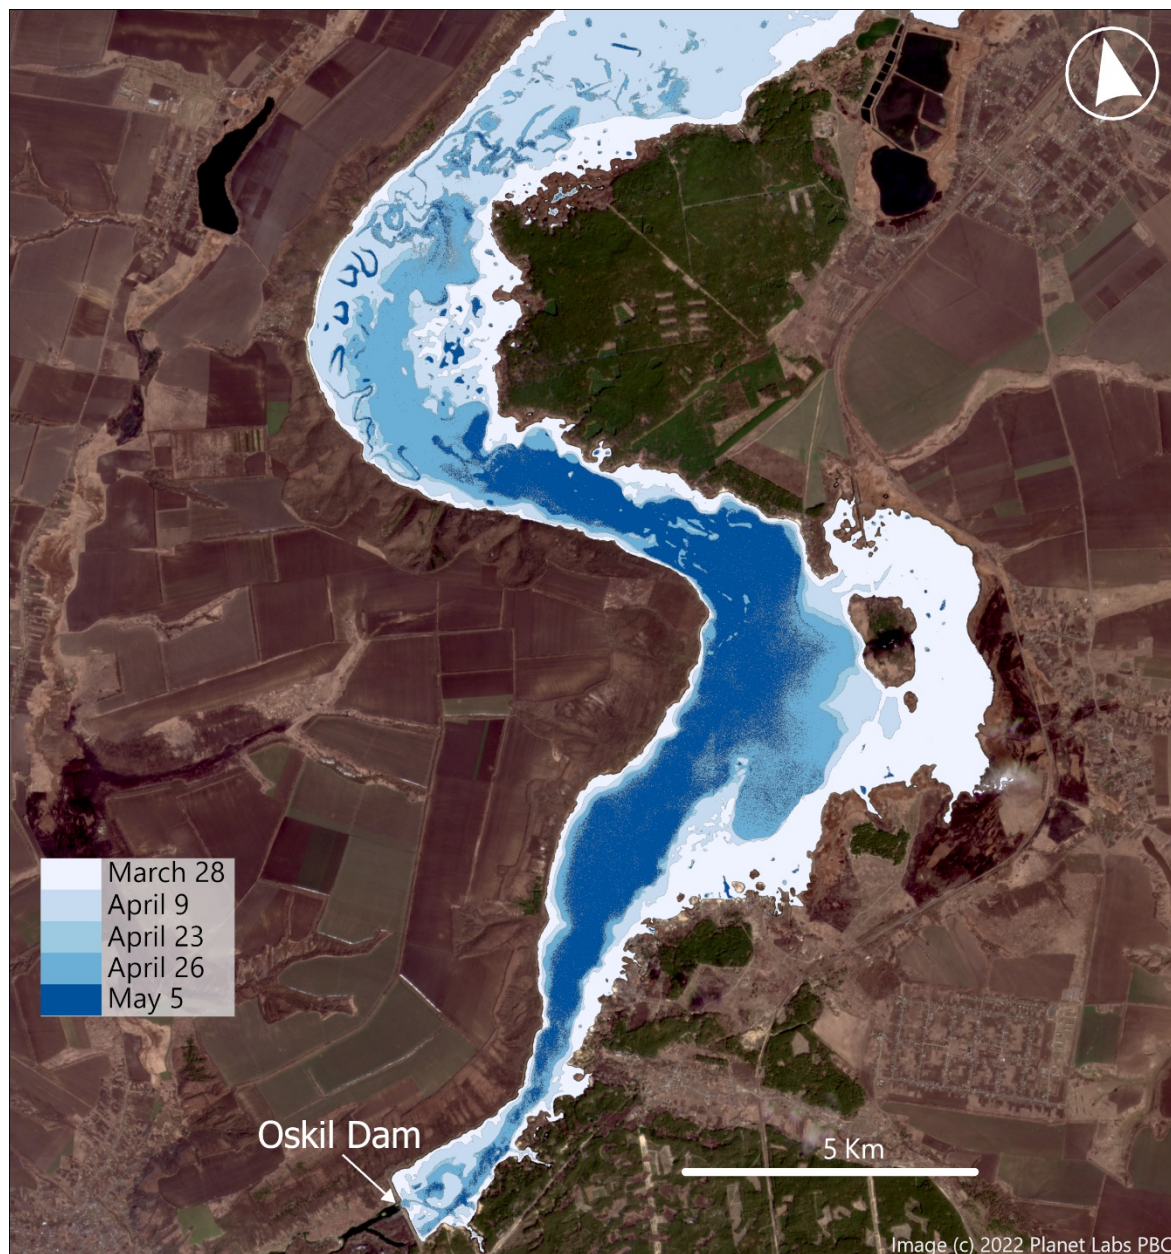
*Figure 4: Water masks for the first five dates (March 28–May 5, 2022) in time-series analysis demonstrate changes in reservoir water levels following damage to the dam in late March 2022.*

We generated water masks for imagery acquired between March 28 and October 19, 2022. We also processed Sentinel-2 imagery to compare our 2022 water masks with those from the five years prior to destruction of the dam and the two years following it. As shown in Figure 5, the data from the baseline period (2017–2021) reveal consistently high water levels comparable to those observed on March 28, 2022, when the reservoir measured 143.1 km<sup>2</sup>. In contrast, the water levels during the two years following the dam damage (2023–2024) remain significantly

lower, indicating severe or permanent structural damage to the dam, which has prevented the reservoir from returning to its previous capacity. Figure 4, which provides a zoomed-in view of an area with significant changes in water extent, illustrates the rapid drainage of the reservoir, which was reduced to 8.7 km<sup>2</sup> by May 5, a decrease of ~94%. The substantial reduction in the reservoir’s water area following March 28 cannot be attributed to natural variability. Water levels between 2017 and 2021 were consistently high, indicating no unusual fluctuations. Furthermore, it is important to note that Ukraine is not currently experiencing a drought. Precipitation levels since 2017 have remained consistent with long-term averages, further highlighting that the marked shrinkage of the reservoir cannot be explained by changes in precipitation.<sup>27</sup>

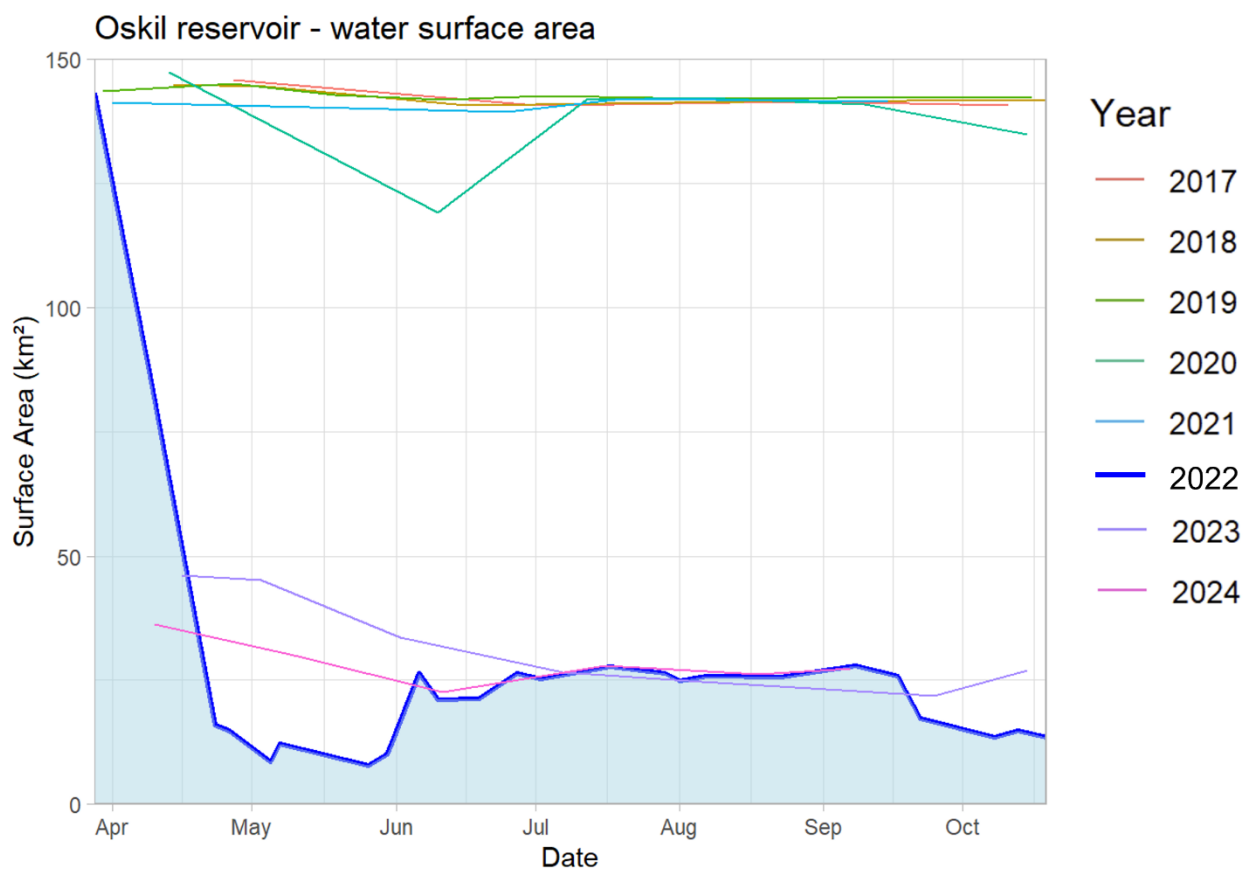
Figure 5: Annual changes in water surface area of the Oskil Reservoir, highlighting the decline in water levels post-dam damage.

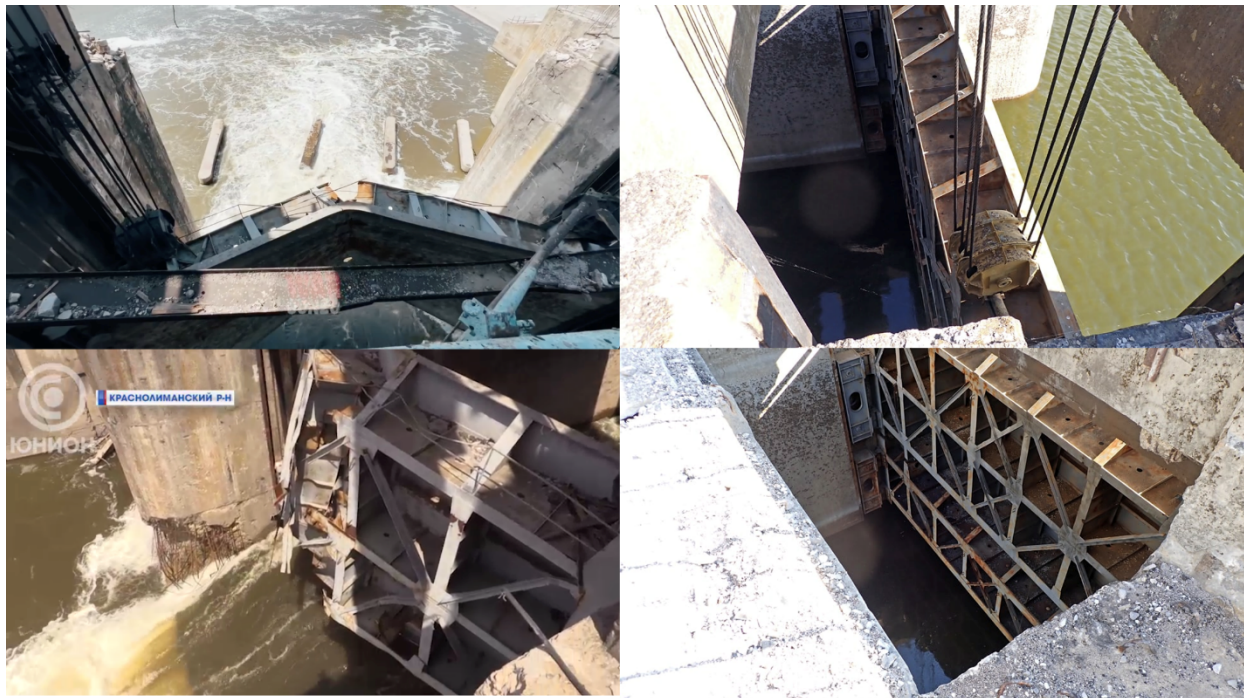
Regarding structural information, the DPR press broadcast provides the first concrete media documenting the damage that Oskil Dam sustained in late March 2022 and attempts to repair the damage. During the separate broadcasts of Pushilin's visit and the visit by DPR's Ministry of Emergency Services, Kostrubitsky and Major General Poplavsky, the individuals, remarked that

one gateway in particular was blown up.<sup>86</sup> Pushilin also specified during his visit that “all the cables were cut out”.<sup>87</sup>

*Figure 10 Left: Screenshot of the destroyed Oskil Dam gate broadcast on the DPR television station UNION. Image published on May 25, 2022. Right: Photograph of an alleged repaired Oskil Dam gate published by the DPR Ministry of Emergency Services. Published on June 7, 2022.*

A few weeks later on June 7, 2022, the Ministry of Emergency Services of the DPR announced that it completed restoring the two dam gates destroyed in late March 2022.<sup>88</sup> The entity’s social media account provided three images to accompany the claim, seemingly showing a functional gate with calmer water flowing through the Dam.<sup>89</sup> While it is not possible to verify from the provided imagery whether the replacement gate was that of the broken gate or an existing one, anecdotal reports from settlements near the Oskil Dam between mid-August and early September 2022 suggest a moderate rise in water levels in the Oskil Reservoir. This could

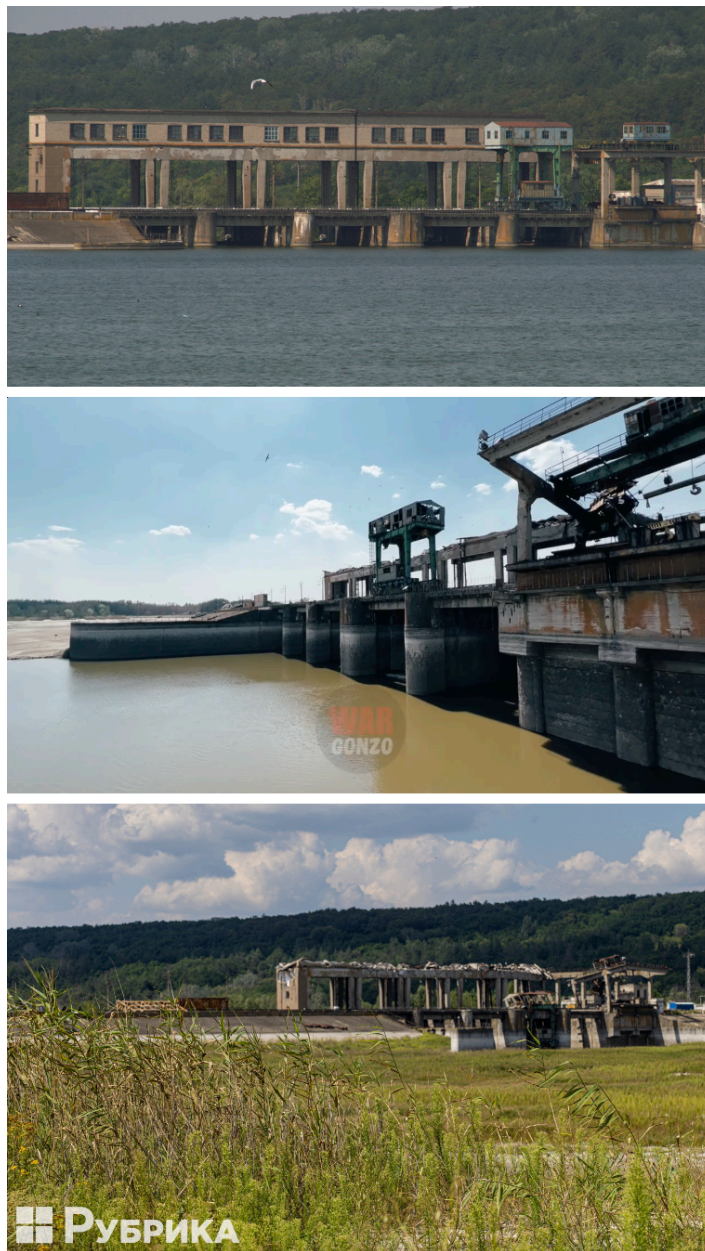
*Figure 11: Oskil Dam facing the Oskil Reservoir in various stages of damage. From top to bottom: 2017; May 21, 2022; August 31, 2023.*

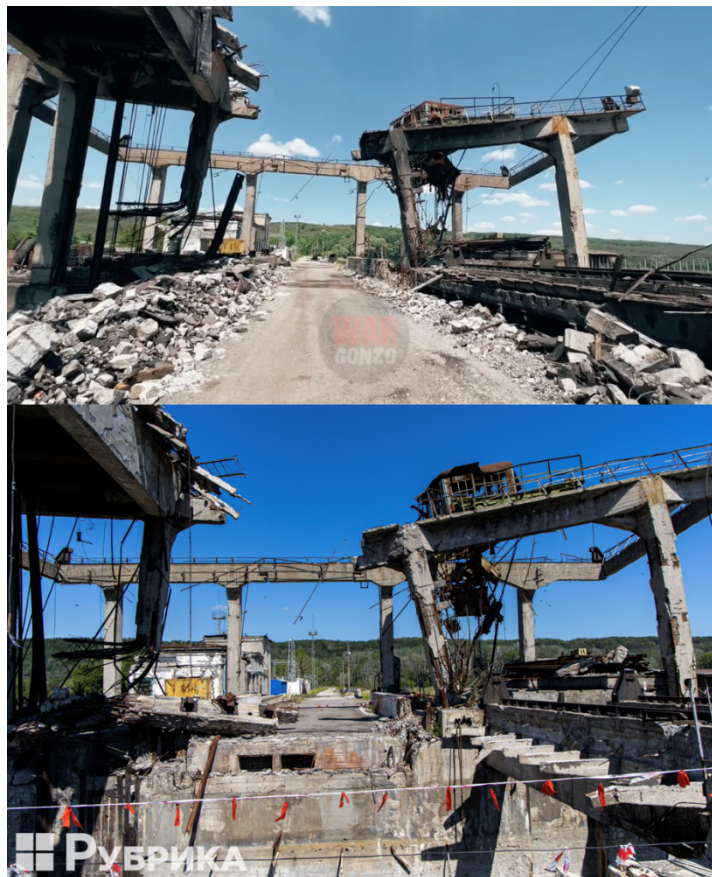
According to an Oskil Dam employee, Russian forces planted 1.5 tons of explosives near the first shutter gate mechanism sometime in September 2022, in advance of the arrival of

Ukrainian forces in the town,<sup>95</sup> the explosion of which resulted in both the gate and the dam road span above it being completely destroyed.<sup>96</sup> Videos dated to and published on Facebook on December 12, 2022, by a Ukrainian National Guard member and deputy of Izyum City Council, confirm that the dam had four closed dam gates and one destroyed dam gate.<sup>97</sup>

*Figure 12: Oskil Dam road span above the first gate in various stages of destruction. From top to bottom: Published on May 23, 2022; published on August 31, 2023.*
